Preassessment Screen Determination for the Metal Bank Superfund Site

Pennsylvania Department of Environmental Protection;
Pennsylvania Department of Conservation and Natural Resources;
Pennsylvania Fish and Boat Commission;
National Oceanic and Atmospheric Administration (NOAA) of the
United States Department of Commerce, and;
The United States Fish and Wildlife Service (USFWS)
of the United States Department of the Interior

November 2014

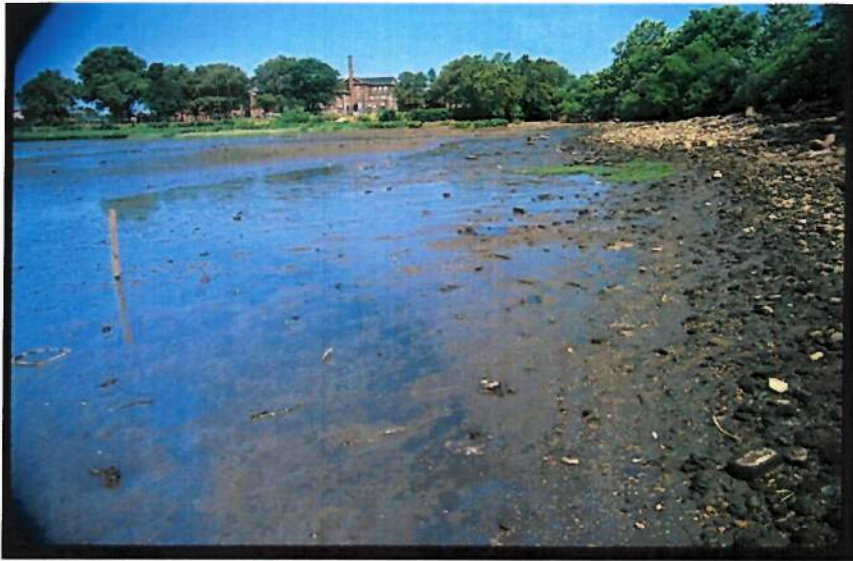
Figure 2. Photograph of the mudflat area at the bank of the Delaware River.

The Site is elevated approximately 15 feet above the River. The western edge of the Site, where it meets the mudflat, consists of a steep, vegetated bank that generally remains above water at all times, with a break in slope at the approximate high-water line. This break in slope marks the transition to a gentler, beach-like slope, which gradually flattens and becomes the mudflat surface. Where the south edge of the Site meets the River, the Site's bank continues downward past the low water mark without a break in slope. Currently, the Site's bank and the slope are stabilized with stone and brick riprap and the remedy stabilized part of the bank with a bulkhead. The slope and mudflat surfaces are inundated during high tide, but are partially or fully exposed at low tide.

Sediments such as those found in the two mudflats areas are generally associated with zones of deposition where contaminants may accumulate to very high levels. Such areas can be either continuing or secondary sources of contamination to streams for several years even after the primary source is cleaned up. In addition, they serve as quiet areas that some organisms seek for refuge or feeding and reproduction, thus acting as areas where exposure is proportionately elevated above other areas associated with the site (USEPA 1994).

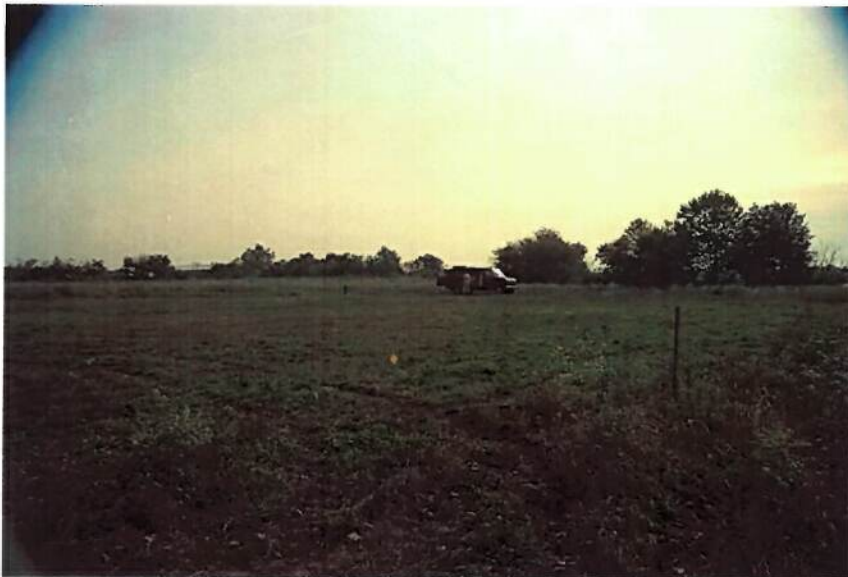
Figure 3. Photograph of the riparian area at the Metal Bank Site.

Soils in the riparian area may have been exposed to Site-related PCBs that were released directly to Site soils during the electrical transformer salvage processes (INDUSTRIAL 2012). Soils in the riparian area and sediments of the mudflats also may have been exposed to Site-related PCBs through erosion and deposition of PCB-contaminated particles and/or through PCB-oil migration in groundwater. The sediments of the mudflats and the rip-rap area are also known to be contaminated with PAHs.

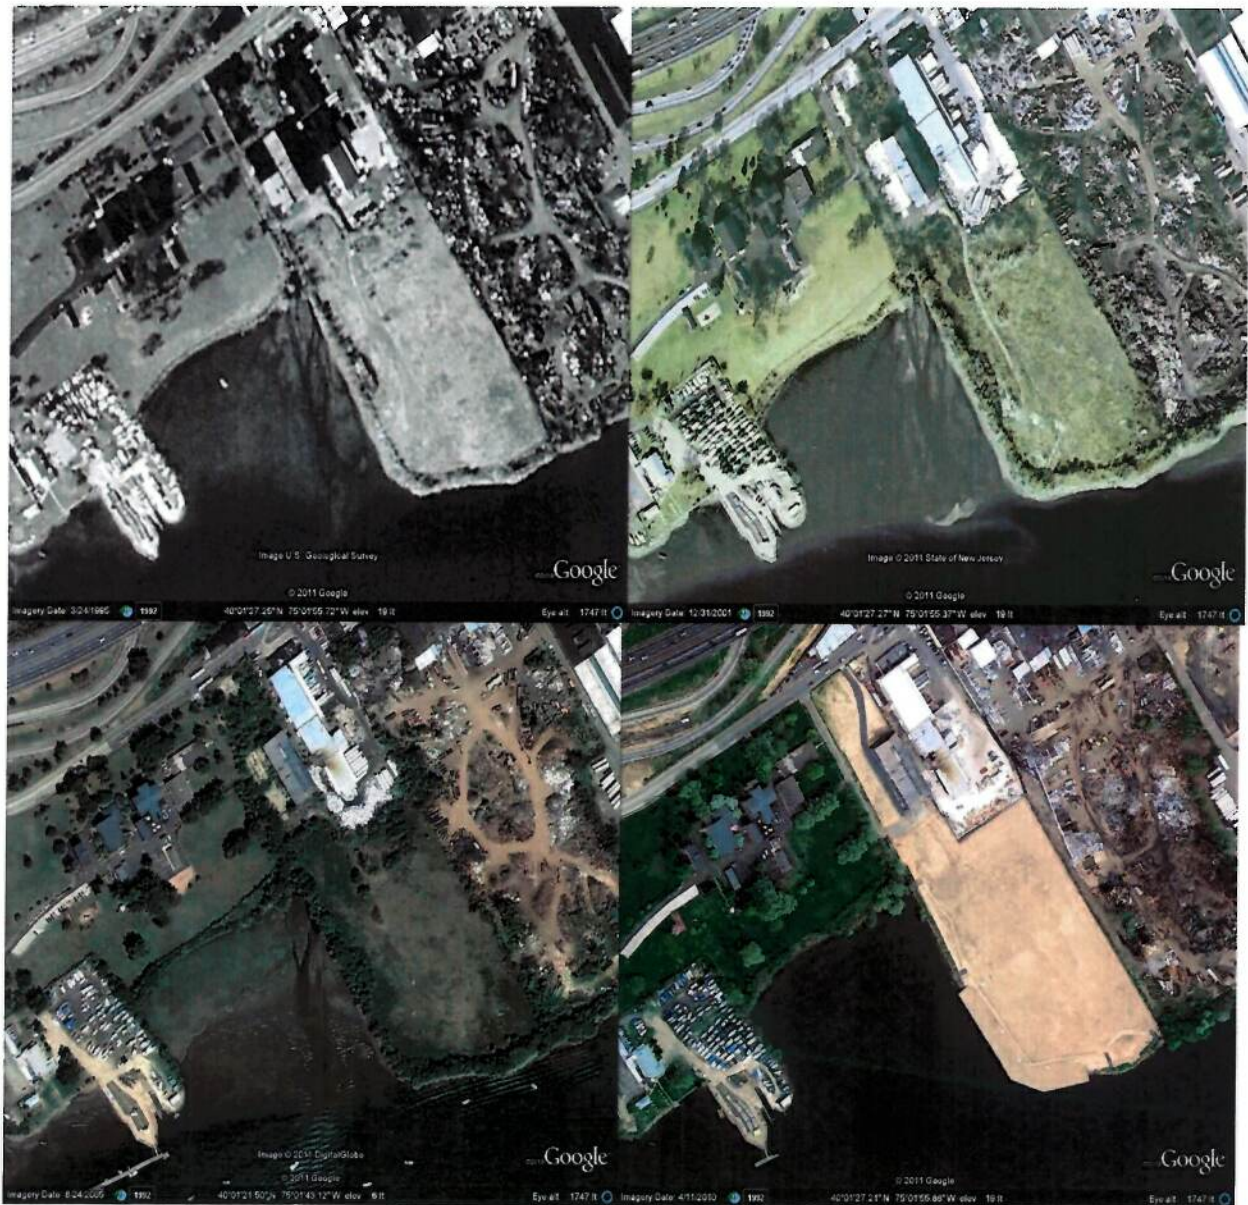
Figure 4. Site Images of the Metal Bank
 Upper Left – 03/24/1995
 Upper Right – 12/31/2001
 Lower Left – 08/24/2005
 Lower Right – 04/11/2010
